# Testing, Monitoring, and Analysis of FRP Girder Bridge with Concrete Deck

## Final Project Report

Andrew Schanck EI, MS  
Research Engineer & PhD Candidate, University of Maine Civil Engineering

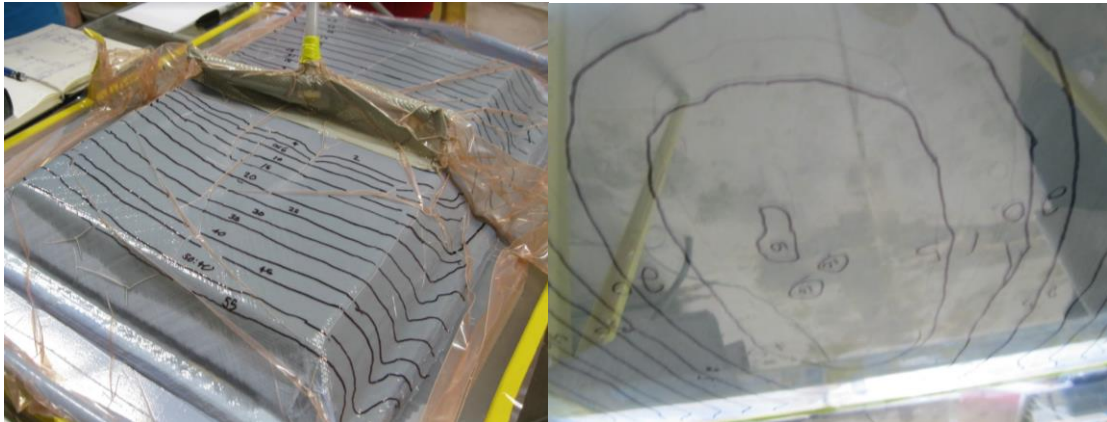
**Figure 1: Test Panel Infusion to Calibrate Part Wet-out (Left: Panel Top; Right: Panel Bottom)**

tailor them for manufacture. Specifically, the resin's viscosity was tuned to ensure full part wet-out before gelation with minimal resin waste. Figure 1 shows a test panel infusion in process, with contours drawn on the top of the vacuum bag and on the bottom of the glass infusion table to indicate resin flow-front at certain elapsed times after initiation of infusion. Infusion of similar test panels had the additional benefit of allowing test coupons to be collected, from which the layup's mechanical properties could be verified.

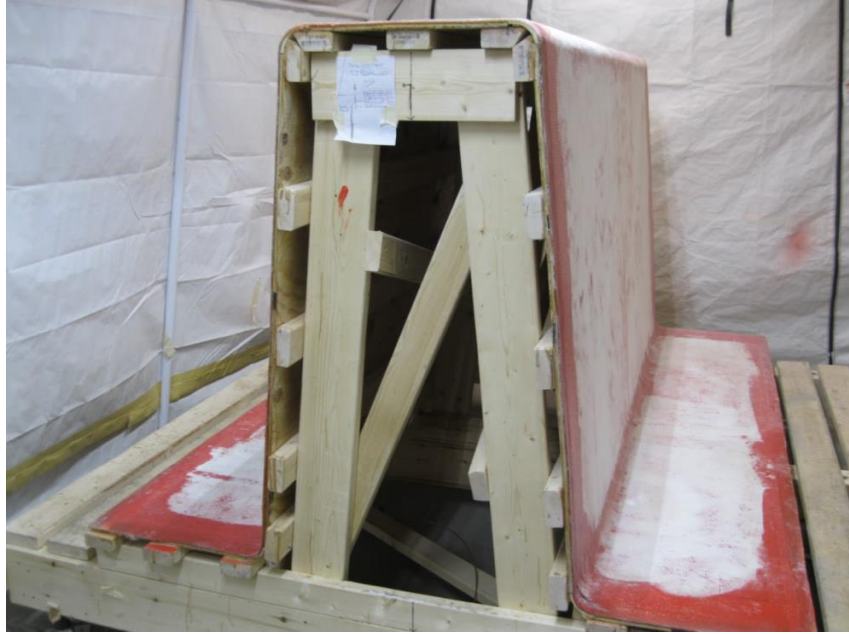
**Figure 2: Male Mock-Up Girder Mold**

In addition to the initial test panels, a small-scale mock-up of the full girder was laid-up, consolidated, and infused, again to verify assumptions of part wet-out time and gain experience before manufacturing full girders. This initial mock-up infusion was again performed in the temporary Bangor facility in April 2019. For this mock-up, a male mold was used, as seen in Figure 2. Infusion of the mock-up, a 6 ft section of girder, can be seen in Figure 3. The use of a male mold greatly facilitated layup, with mold sides easily accessible. Unfortunately the outside of the part (the side that would be visible on the full-scale girders) developed unsightly wrinkling on transition radii and a generally poor surface finish as compared with the inside surface which was laid directly on the mold. The radial wrinkling can be seen in Figure 3 at the transition between bottom flange and web. For this reason, all future mock-ups and the actual girders were laid up onto a female mold.

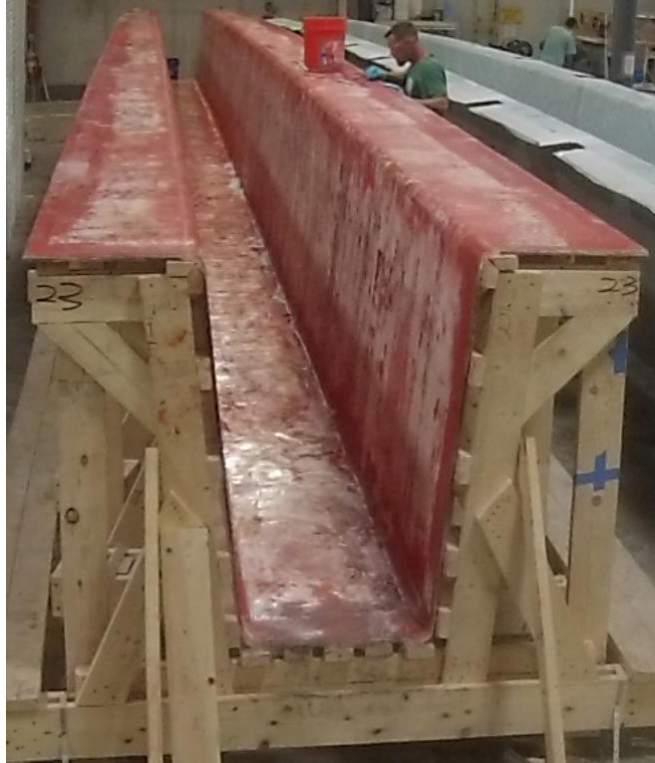
**Figure 4: Full-Size Female Girder Mold**

After the initial test infusions and small-scale mock-up, production was moved to AIT's permanent production facility in Brewer, Maine. There, a full-size female mold, seen in Figure 4 was constructed, faired, and seasoned before a second small-scale mock-up girder was infused. The second mockup, much like the first, consisted of a 6 ft section of full girder layout. For this mock-up, a HDPE caul plate was applied to one of the top flange to web transition radii, intended

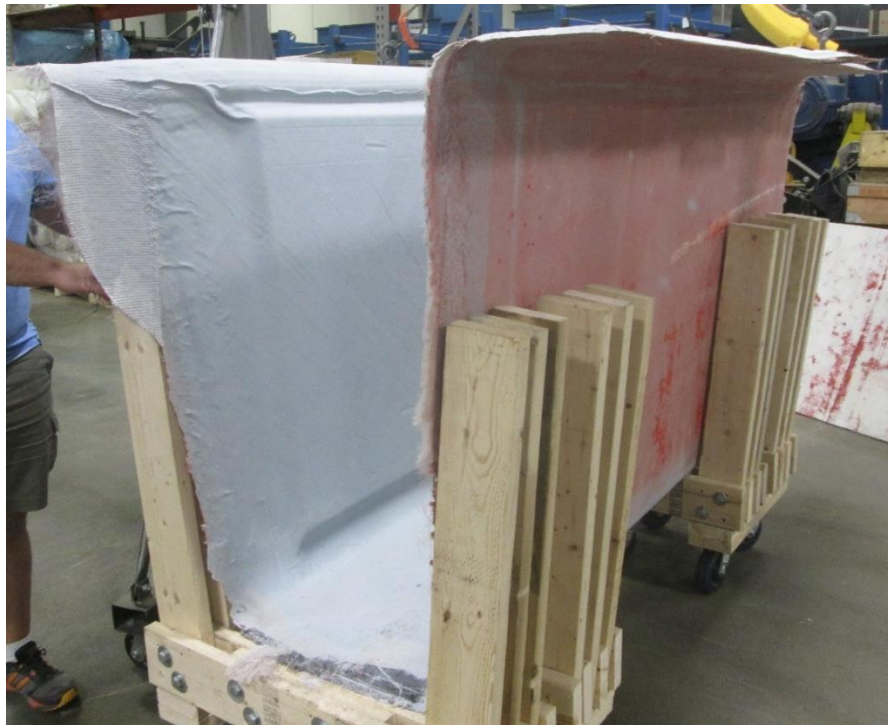
**Figure 6: Infused, Cured Second Girder Mock-Up**

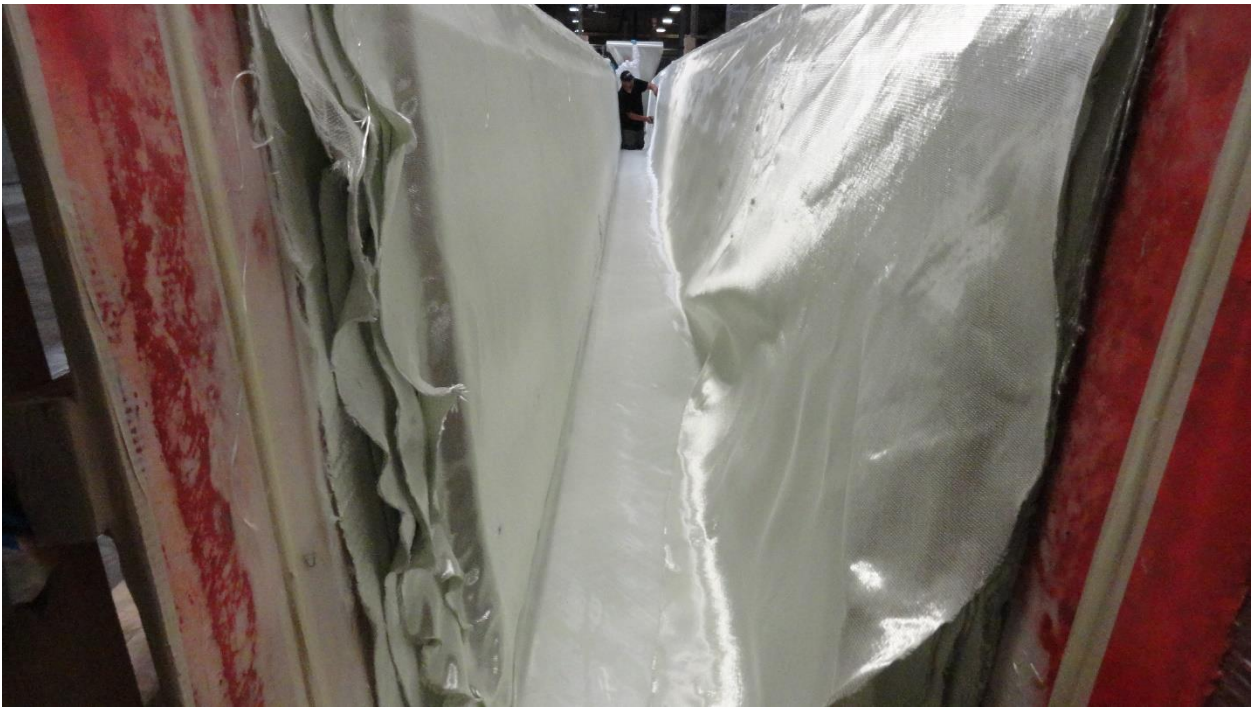
**Figure 7: Layup of Girder Reinforcement in Process**

1. Prepare mold by repairing any defects from the previous infusion, and apply wax and release agents
2. Place reinforcement into the mold according to the lay-up schedule using spray adhesives to temporarily tack them in place (Figure 7)
3. Install infusion consumables (resin feed lines, vacuum lines, flow improvement media, vacuum consolidation bagging, etc.) (Figure 8)
4. Consolidate part by drawing high vacuum pressure beneath the vacuum bag
5. Infuse the consolidated part with initiated, catalyzed resin and allow to cure (Figure 9)
6. Remove the cured part from the mold and perform post-processing (Figure 10)

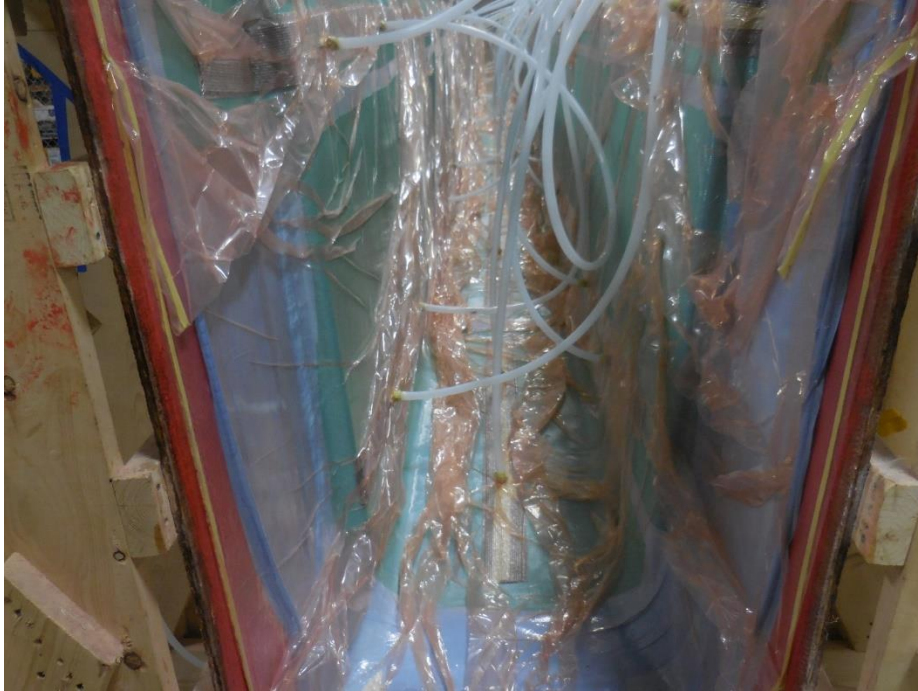
**Figure 8: Consolidated Girder with Flow Media and Vacuum/Resin Feed Lines Visible**

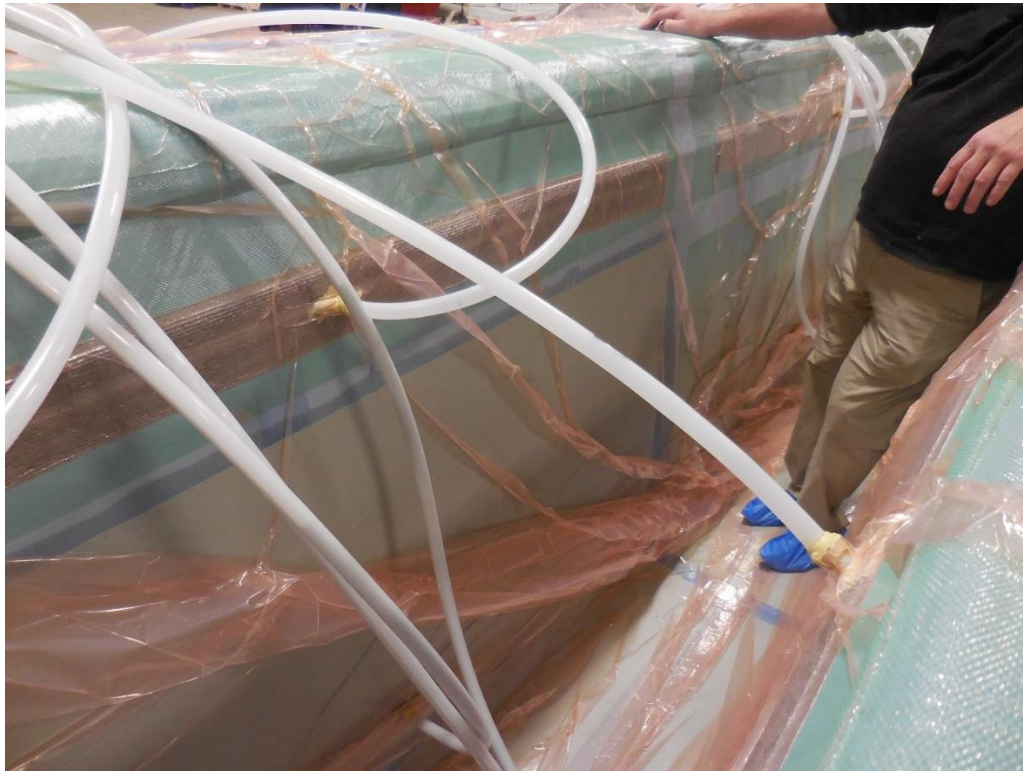
**Figure 9: Infusion of Resin into Vacuum Consolidated Reinforcement**

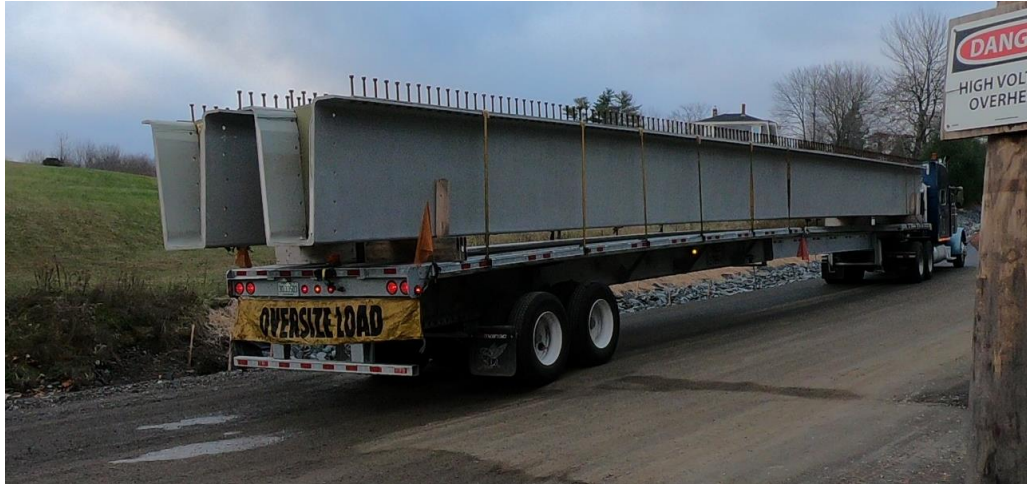
**Figure 11: Girders Arriving at Bridge Site**

After the original structure had been removed, the site-work completed, and the substructure constructed, the superstructure construction commenced. The five CT girders were transported from AIT to the site on November 5, 2020 and placed November 5 and 6, 2020. Figure 11 shows the first two girders being delivered to the site by extended flatbed truck. Transport of multiple CT girders at a time exemplifies one of the advantages of CT girders over comparable prestressed concrete girders for which they are designed to compete. Once arrived, girders were lifted from the truck and placed on temporary supports for staging and preparation work. Where present, utility hangers were installed while girders were staged which spanned between girders transversely and from which utilities (municipal water and sewer lines) were hung. The fact that

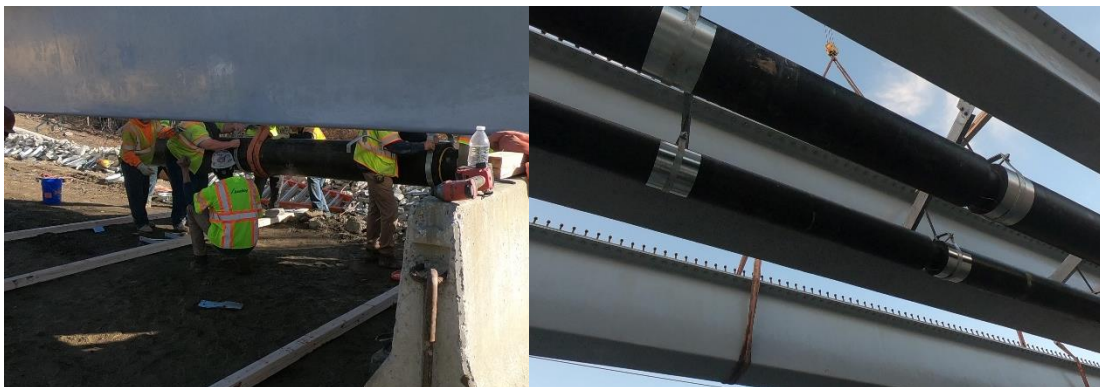
**Figure 12: Utility Hangers (Left: Installation; Right: In Place)**

two girders could be placed at a time with a single crane is a direct benefit of their light weight, and also simplified utility installation. This process and the resulting hanger system can be seen in Figure 12. Girders were then lifted into place by crane, with hanger-connected girders being lifted together as a unit. This can be seen in Figure 13, with girder ends sitting on bearings in Figure 14.

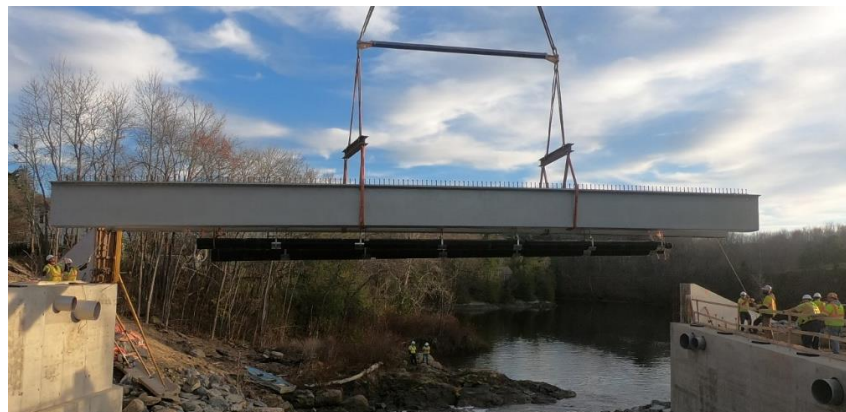
**Figure 13: Two-Girder Unit Being Lifted into Place**

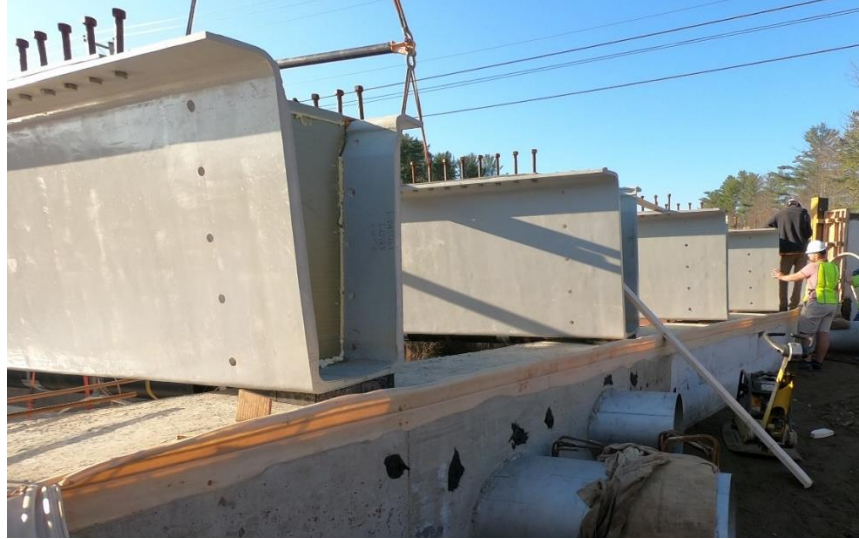
**Figure 14: Girder Ends Placed on Bearing Pads**

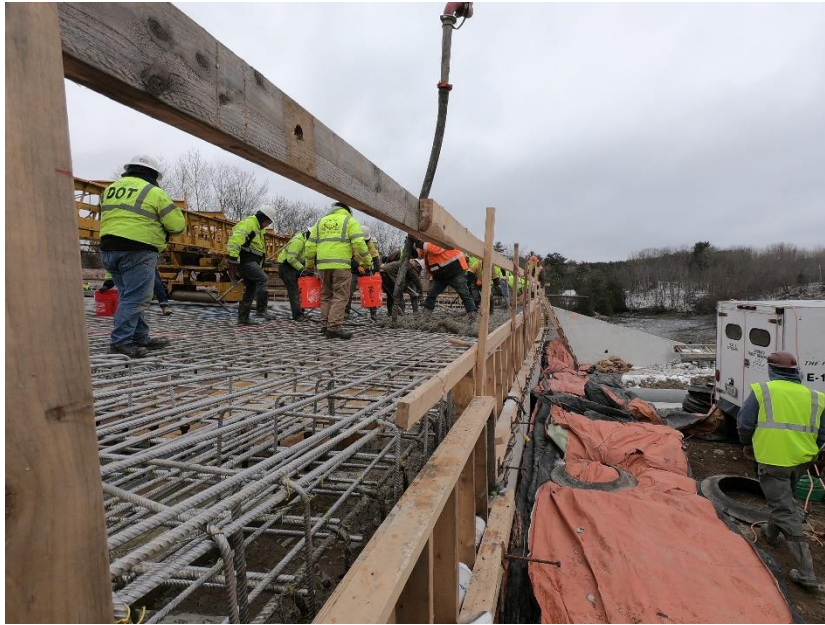
**Figure 15: Reinforced Concrete Deck Pour**

After girder placement, the concrete elements of the bridge were formed, reinforced, and cast. In general, the concrete used was a standard DOT mix with nominal compressive strength of 4 ksi and was reinforced with ASTM A955 stainless reinforcing bar. Three separate concrete pours were carried out, with construction joints at the interface and reinforcing bars providing dowel action. First, the backwalls were poured which encased the ends of the girders and against which the roadway base was backfilled once sufficiently cured. After this, the bridge's deck was formed and poured. This pour took place December 8, 2020, with concrete placed by pump truck as seen in Figure 15. Due to the cold temperature experienced during the pour and predicted freeze-thaw cycling over the deck's lifetime, air entraining admixtures were incorporated which raised the air entrainment to about 8.5%. Finally, during the final pour, the bridge's curbs and sidewalks were cast. Once all concrete elements had cured sufficiently, a temporary asphalt wearing surface was laid, which was subsequently replaced with a permanent wearing surface the following spring.

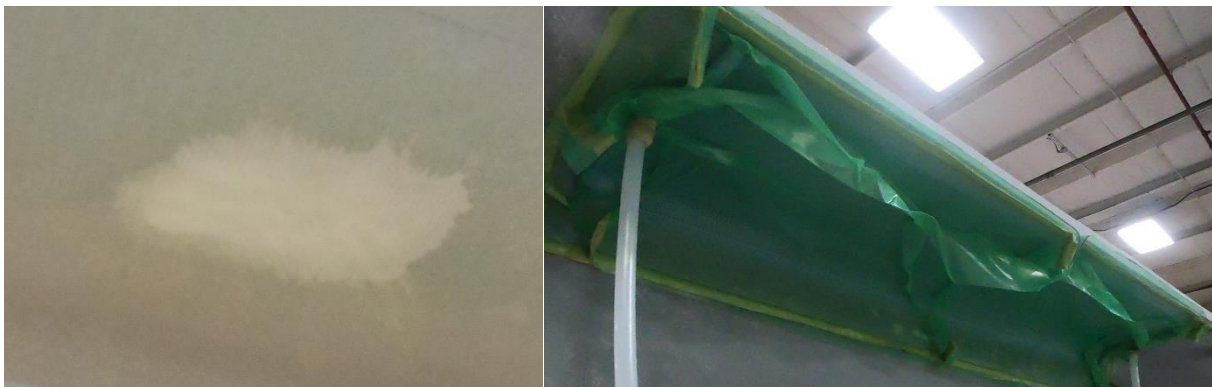
**Figure 16: Right: Minor "Dry Spot" Surface Imperfection Left: Secondary Repair Infusion**

After infusion and curing, inspection of each of the girders revealed imperfections and defects requiring remedial actions to be taken. Most of these imperfections were minor and aesthetic in nature, requiring straightforward repairs. These minor imperfections consisted mainly of small areas of incomplete resin wet-out (so-called "dry spots") on the girder's surface a few laminae deep. An example of one of these dry spots is shown in Figure 16. In general, dry spot imperfections tend to result from inadequate mold surface preparation, overuse of temporary adhesive during layup, or air bubbles in the feed resin. Repairing these imperfections required straightforward secondary surface infusions, as can also be seen in Figure 16, which could be completed relatively quickly. However, because multiple dry-spots were present on each of the five girders, significant post-processing time was added to the overall manufacturing schedule, and required a significant amount of additional hand labor.

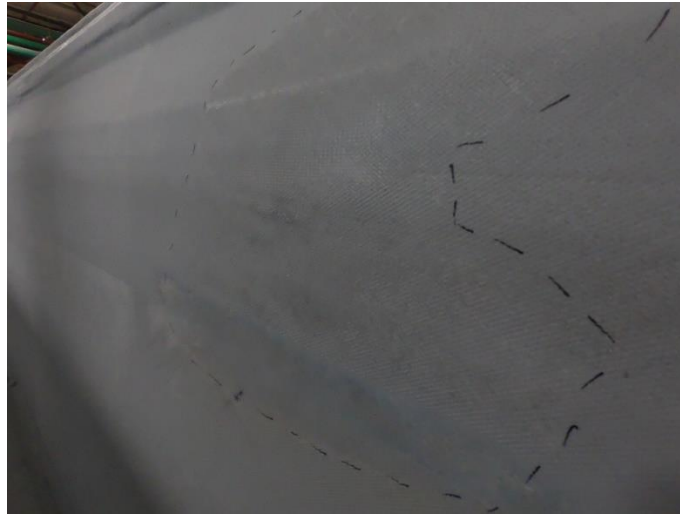
**Figure 17: Debulked Structural Defect**

In addition to the minor surface imperfections present after infusion of each of the girders, the inside face of one of Girder 5's webs was found to have a significant area of improper resin cure and debulking, seen in Figure 17, which required extensive structural repairs. In contrast to the dry spot imperfections found elsewhere on the girder and on others, this defect was quite large

in area and extended through the web's entire interior facesheet to the core. In addition, whereas dry spot imperfections are devoid of resin, this defect was saturated with uncured resin. Repair of this imperfection required removal and replacement of the spoiled fabric in the affected area, followed by thorough cleaning, layup of new fabric, and reinfusion and curing. This process can be seen in Figure 18.

Based on analysis of the defect and the observation that it was localized to the area of a resin feed-line, it was determined that this defect was caused by contamination of resin with water, which infused the area local to the feed line. To prevent excessive heat build-up during infusion, catalyzed feed resin was kept in thin bucket-liners, which were in turn placed in buckets of water. It is possible that some of this cooling water spilled into the feeder resin, contaminating it and inhibiting its proper curing. This resin was infused into the girder in the location of the eventual defect. The fiber debulking in the area infused by contaminated resin was due to re-exposure to atmospheric pressure after vacuum was released.

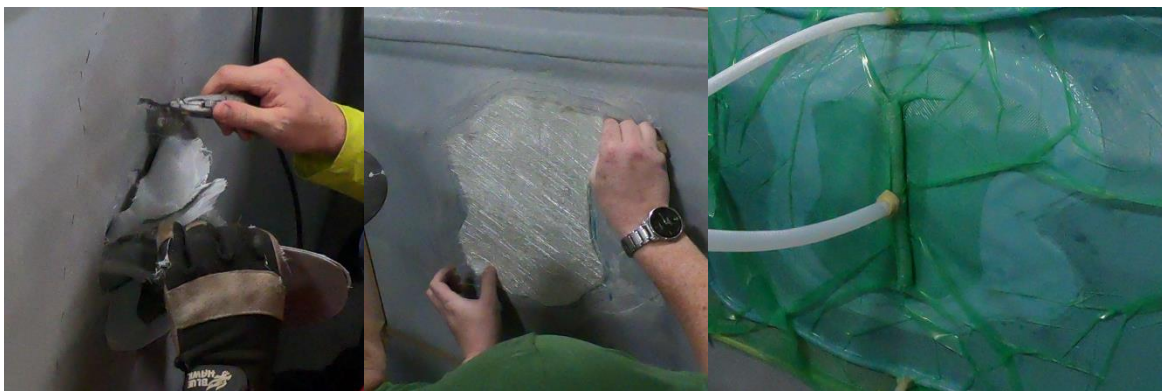
**Figure 18: Repair of Structural Defect: Left: Removal of Affected Laminae, Center: Layup of New Fabric, Right: Re-Infusion**

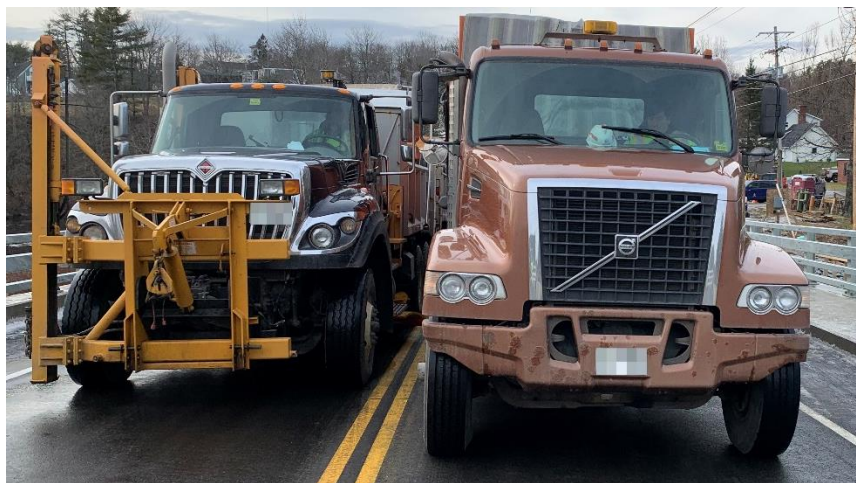
**Figure 19: Wheeler Type Dump Trucks Used for Loading**

As in previous NDLLT conducted in previous studies [7,8] the HGMB was loaded by two or four overloaded wheeler-type dump trucks positioned in one of five loading scenarios. These dump trucks were furnished by MaineDOT, and their individual wheel weights, tire contact areas, and wheel bases were measured on site. Each truck had an average gross vehicle weight of 65.6 kip, for a total applied load of 262.5 kip with all trucks on the bridge. Two of these trucks can be seen in Figure 19. The specified truck positions and test runs were selected to maximize moment applied to different parts of the bridge and to examine the bridge's response to differing load levels. Test naming convention follows the pattern: "Test Series\_Load Position\_Repetition", where "Test Series" denotes the type of test ("SBS", "MAX", or "ALT" as explained below), "Load Position" denotes transverse truck position (1 = downstream, 2 = centered, and 3 = upstream), and "Repetition" denotes the repetition number when multiples of the same test configuration were conducted. In the "SBS" series of tests, two trucks were placed on the bridge with their tandem

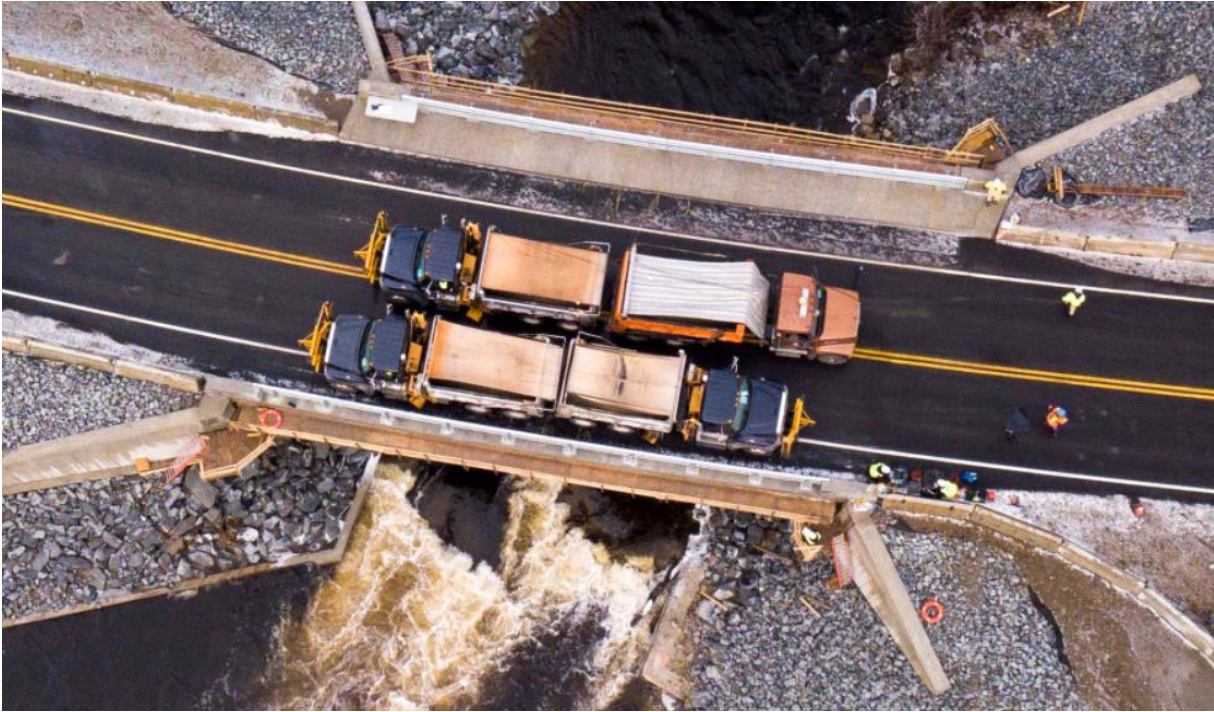
**Figure 20: Aerial Photo of MAX\_1\_1 Test (Courtesy of Advanced Infrastructure Technologies)**

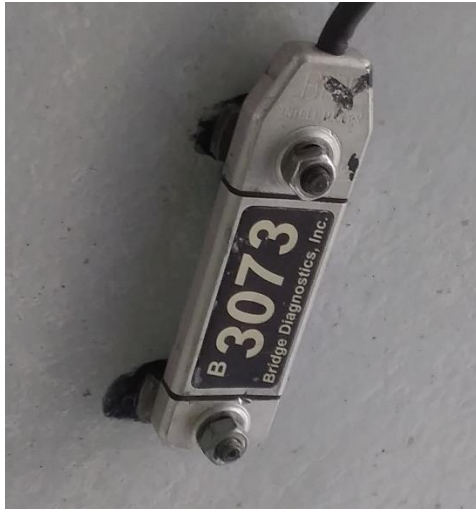
**Figure 21: Strain Transducer Mounted to the Bottom Flange of a Girder**

Instrumentation used to monitor bridge response during loading was again very similar to that used in NDLLT performed in previous studies [7,8]. The response of the bridge to loading was measured as strain using the Wireless Structural Testing System (STS-Wi-Fi) produced by Bridge Diagnostics Inc. [9]. This system uses a mobile base station to communicate with six nodes, with four, full-bridge strain transducers connected to each node. Strain transducers measure strain continuously during tests at a sampling rate of 10 Hz. The system communicates with a dedicated laptop running BDI-specific WinSTS data acquisition software, which automatically performs analog to digital signal conversion and rectification of voltage to strain data using built-in calibration factors. One of the 24 transducers used during testing is shown in Figure 21 mounted under the bridge at mid-span. A schematic of the entire network is shown in Figure 22 including strain and displacement sensors, wireless nodes, and the data recording laptop.

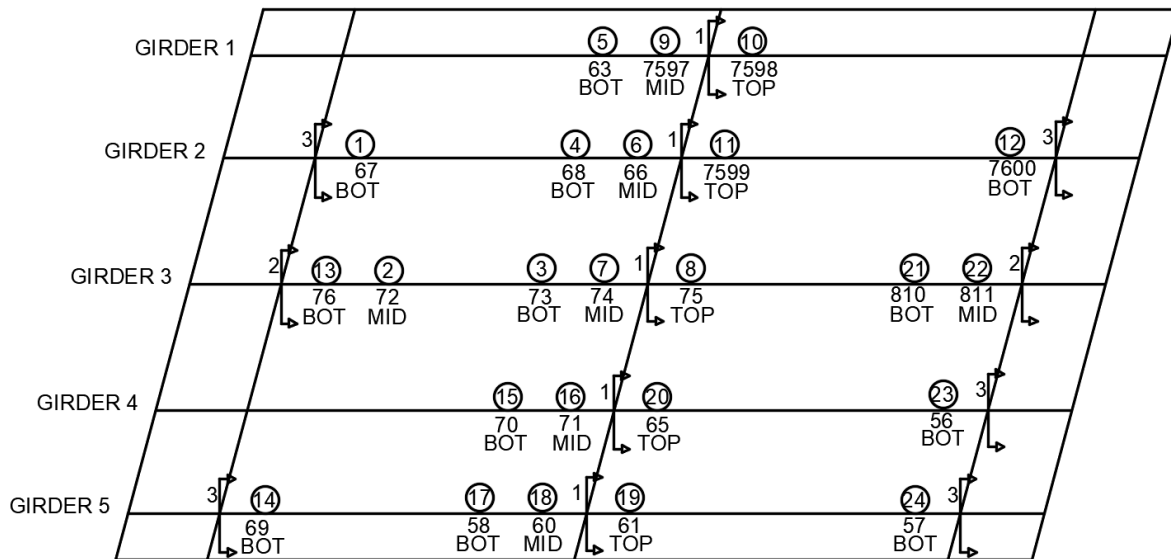
Figure 24: Plan View of Sensor Layout

exception of Girder 1, which was instrumented only at midspan, each of the girders also had at least one sensor applied to its bottom flange near the support. These sensors were applied to identify unintended end fixity, manifested as large negative girder end strains. Figure 24 presents a plan-view schematic of the bridge showing the location of each sensor, with the terms “BOT”, “MID”, and “TOP” referring to the same vertical positions shown in Figure 23.

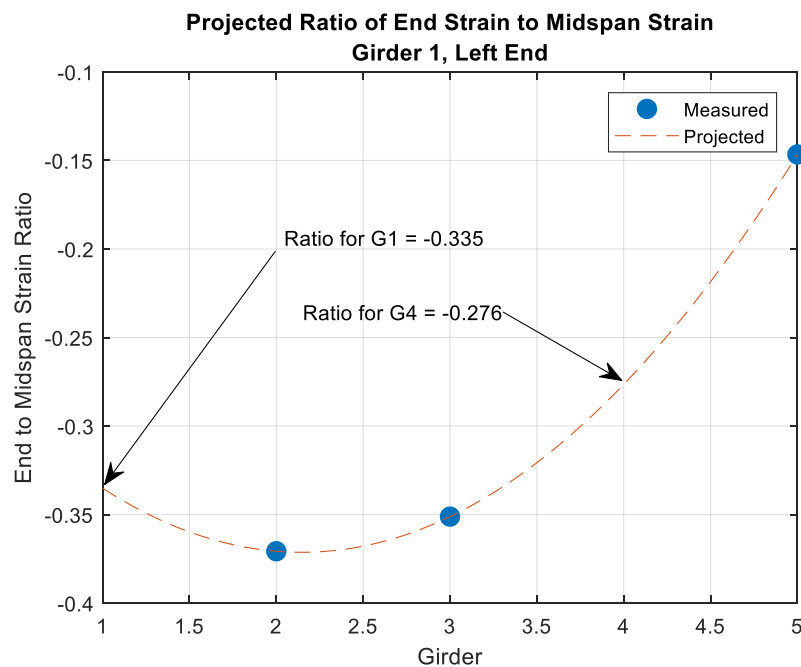
**Figure 26: End-to-Midspan Strain Ratios – East End**

Although this method is rational, it does require that strains at both ends of all girders be known. However, strains were only measured at the West end of Girder 4, and no strains were measured at either end of Girder 1. It was observed that the ratios of end strain to midspan strains for each end of the bridge were roughly parabolically distributed across the bridge's width. To predict the missing end strains for Girders 1 and 4, parabolic functions were fit to the ratios  $\varepsilon_e/\varepsilon_m$  and plotted as shown in Figures 26 and 27 for the east and west ends of the bridge, respectively. Using these projected ratios, the missing end strains were calculated, again taking positive end strains equal to zero.

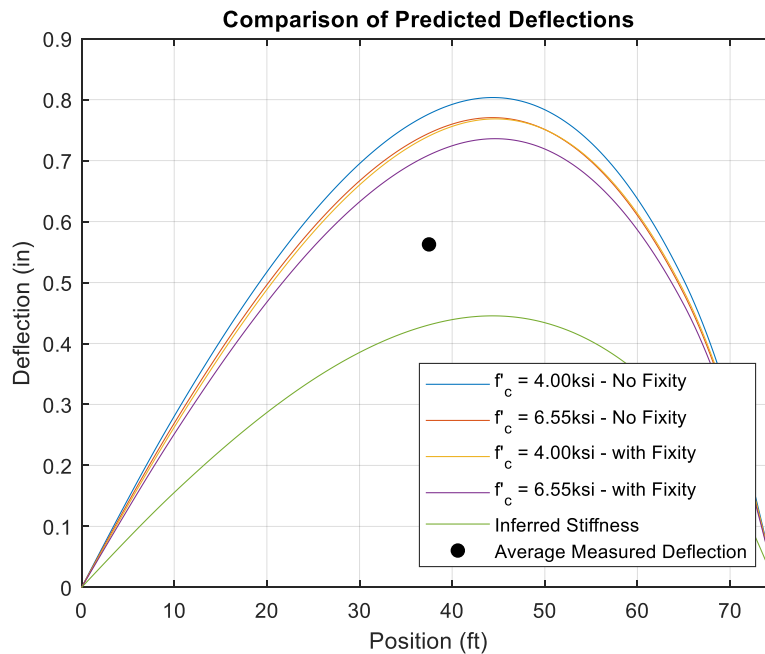
**Figure 28: Comparison of predicted and Measured Deflections**

For comparison with measured deflections, the bridge's deflections under SBS\_2\_2 loading were predicted both with and without the consideration of observed rotational fixity, and using both the nominal (4.0 ksi) and measured (6.55 ksi) concrete compressive strength, for a total of four analyses. The effect of rotational fixity was included using the average end strains recorded in each girder and the nominal flexural rigidity of each corresponding girder at its end. When summed, these moments give  $M^-$  in Eq. 12, which was assumed independent of  $x$ . To neglect the effects of observed rotational fixity  $M^-$  was simply taken as zero with the remainder of the analysis identical. Figure 28 presents the results of these analyses and compares them with the average deflection measured by AIT at midspan. As can be seen, the maximum deflections from each of the predictions significantly exceeded the measured average deflection, even when the effects of rotational restraint were considered. This suggests that the overall bridge system is significantly stiffer than nominal properties would indicate.

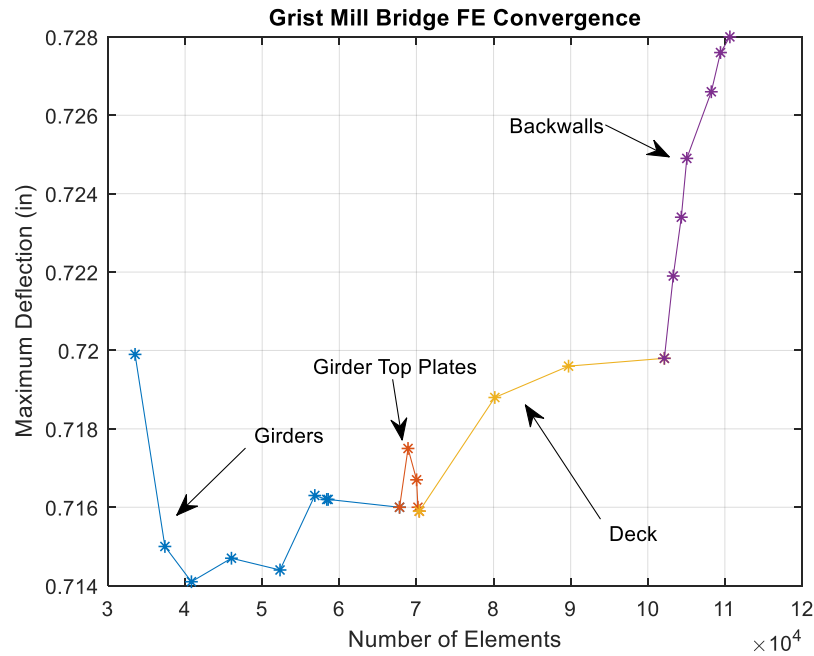
**Figure 30: Mesh Refinement Convergence Study**

In total, the models each contained around 160,000 elements and 339,000 nodes. The mesh density of different components was determined by a convergence study, which tracked maximum vertical deflection as a function of number of elements. The results of this study can be seen in Figure 30. It should be noted that the number of elements determined from this convergence study did not include the elements making up the wearing surface, deck reinforcement, or rails, which contribute the remaining elements. Additionally, although it appears that deflection does not converge when increasing the number of elements in the backwalls, a large number of data points

exist at the end with very little increase in deflection, and the scale of the plot makes these hard to see.
